RE: Site Inspection, Western States Mineral Corporation, Drum Mine, M/027/007, Millard County, Utah

Purpose of Inspection: To discuss the final closure of partially closed adits in the bottom of the SWEX Pit.

DRUM PROJECT: FINAL RECLAMATION & SWEX PIT ADIT CLOSURE

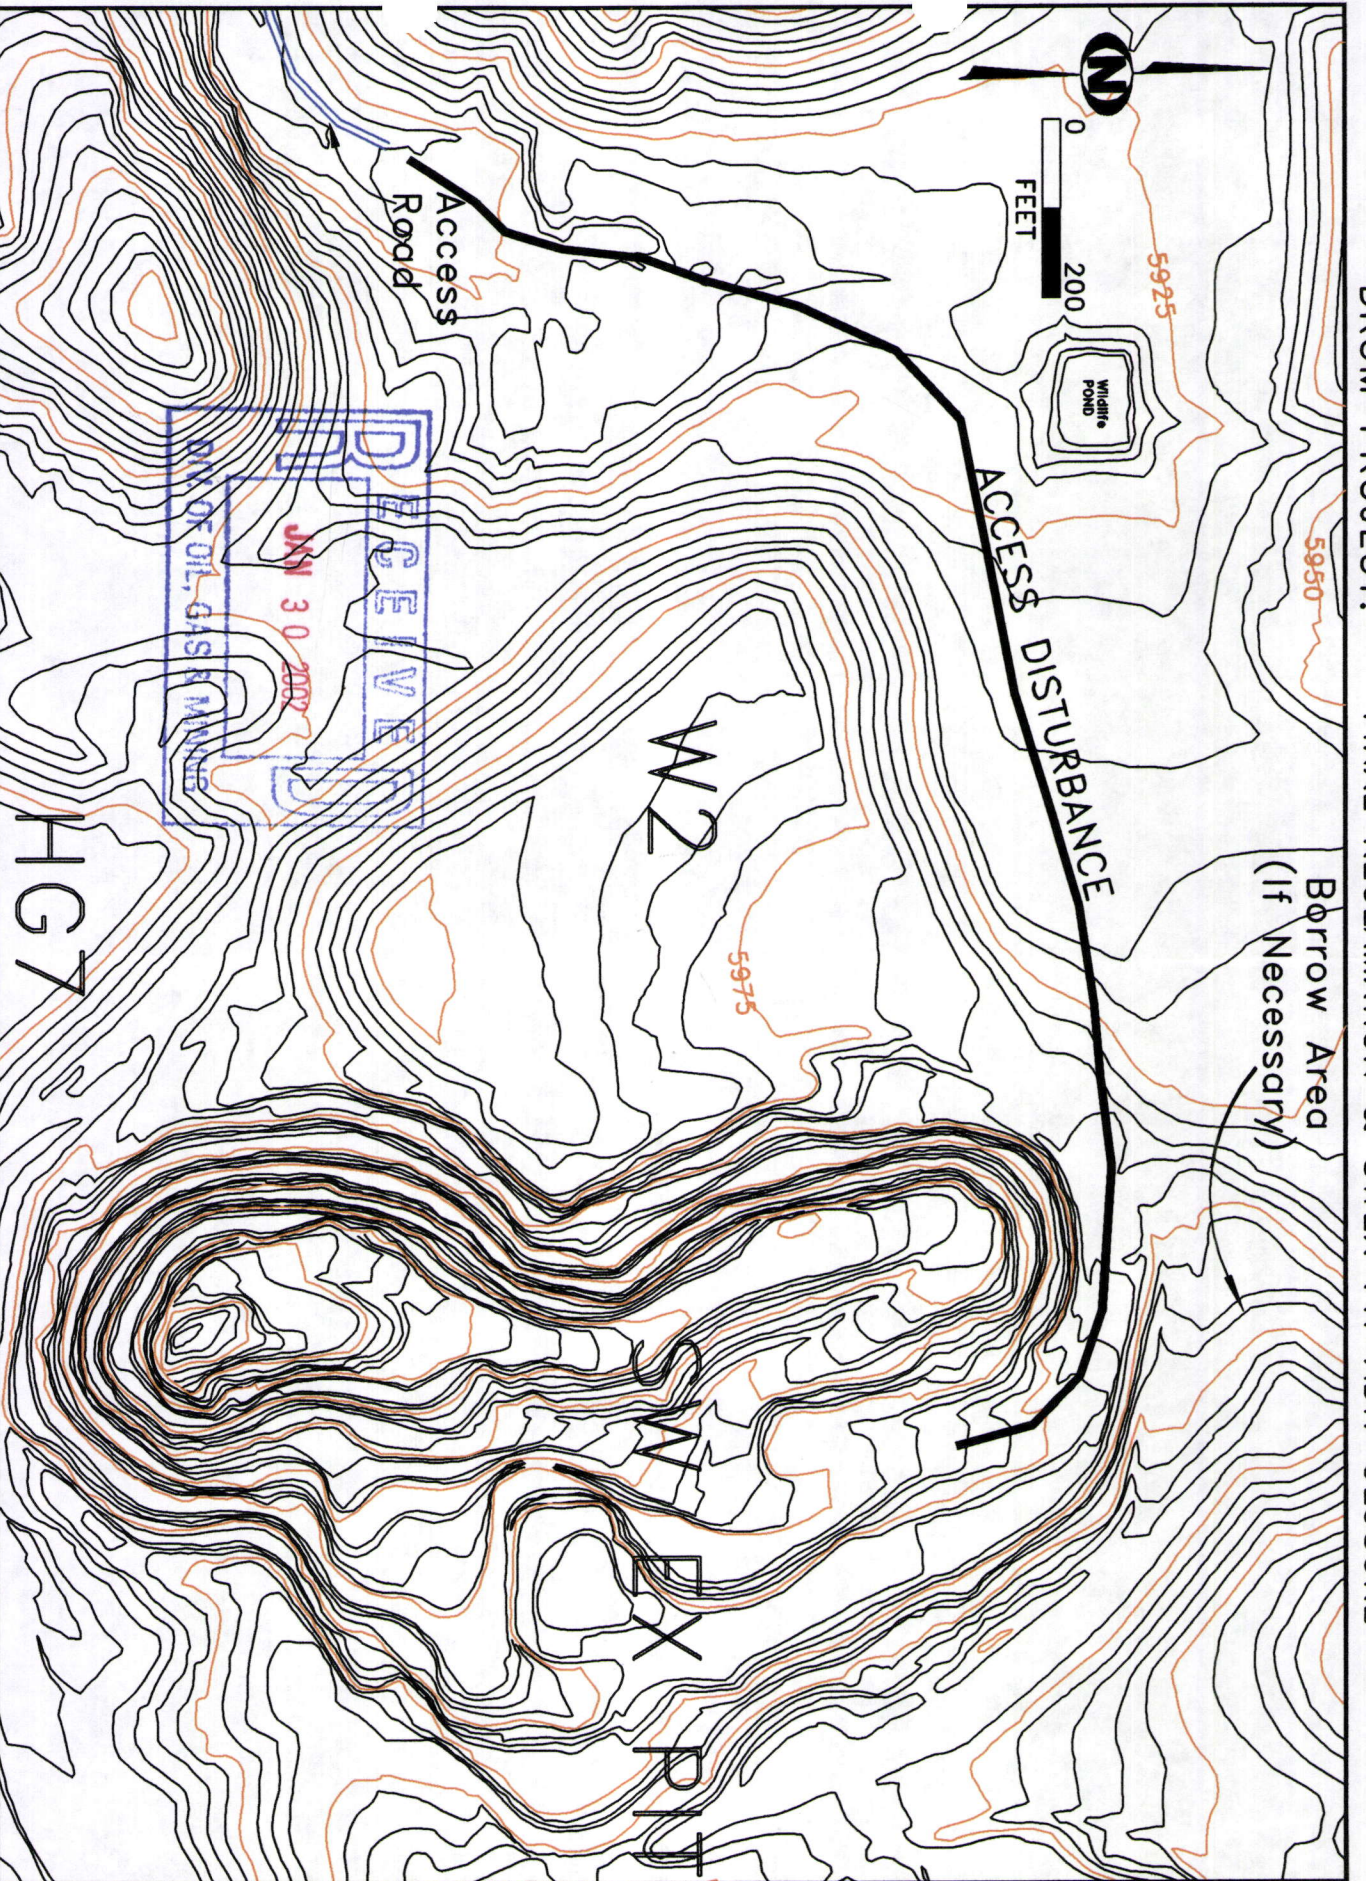
A road will need to be pioneered to the SWEX pit to allow Rancho to get its equipment to the work site. This road will also be used by Rancho to transport fuel and personnel to the bottom of the pit. The road will be ripped and seeded when the work on the adits has been completed. A map is attached indicating the proposed road and alternate borrow area.

It was decided that, if possible, the material that will be used to close the openings would be taken from material that remains in the bottom of the pit. If there is not enough material available in this area, and as an alternate, additional material will be mined from LG-2 dump located near the road entering the pit.
